FLIGHT VIBRATION SURVEY OF C-130A AIRCRAFT*CHARLES E. THOMAS*

TECHNICAL DOCUMENTARY REPORT No. ASD-TDR-62-267

MARCH 1962

DIRECTORATE OF ENGINEERING TEST
AERONAUTICAL SYSTEMS DIVISION
AIR FORCE SYSTEMS COMMAND
WRIGHT-PATTERSON AIR FORCE BASE, OHIO

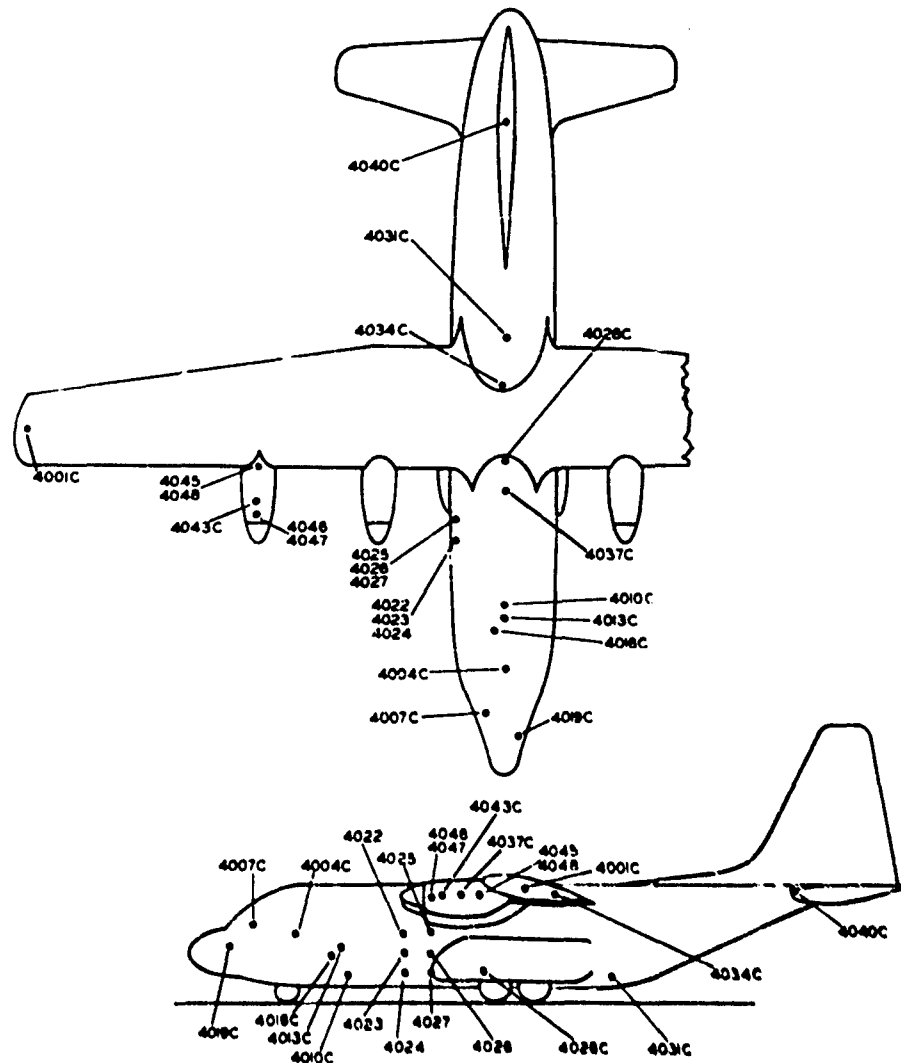
Figure 1. Schematic Presentation of Pickup Locations

Forty-eight MB Type 124 velocity pickups were mounted in clusters (2 or 3) and individually at 21 separate test points on the aircraft engine and structure. The locations are summarized in Table II and shown in Figure 1. The Type 124 velocity pickup has the following characteristics:

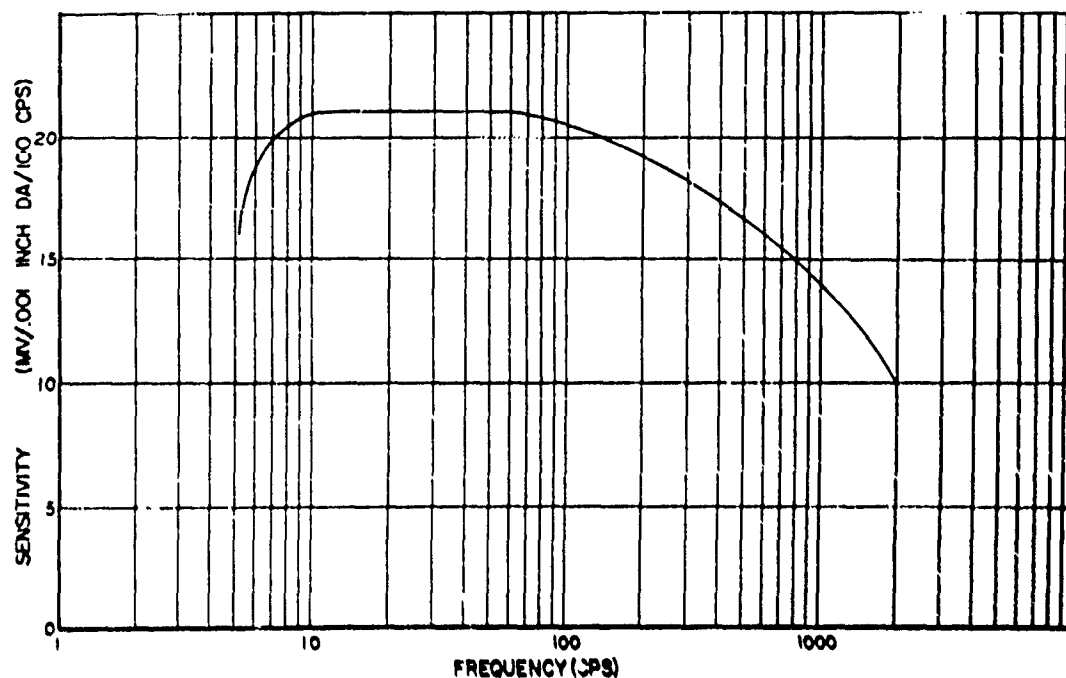
Figure 2. Frequency Response of MB Type 124 Vibration Pickup

A typical response curve is shown in Figure 2. The three-position mounting blocks used to attach the pickups to the vehicle structure have no resonances below 500 cps.

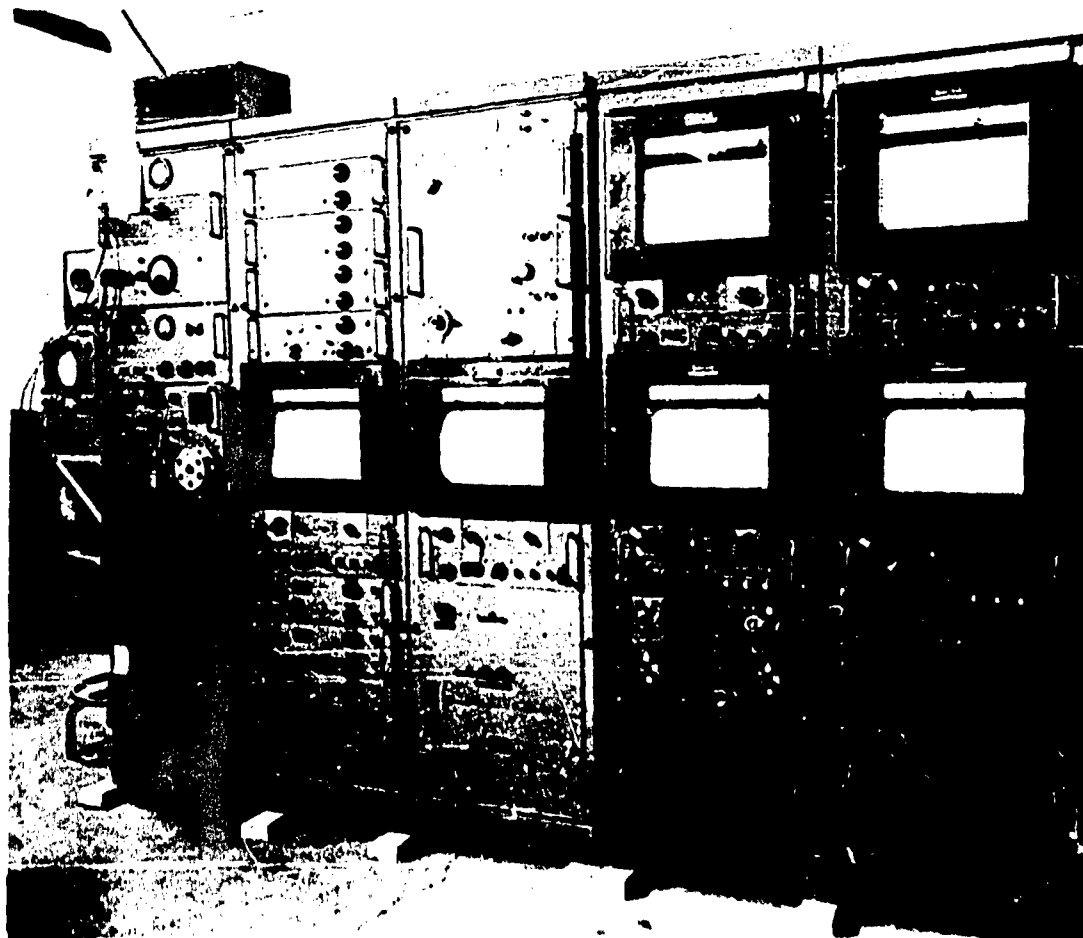
Figure 3. Automatic Tape Playback and Analysis Equipment

The reels of tape were edited and each five-second record (data sample) was spliced into a continuous loop and properly labeled. These records were analyzed by means of a Davies Model 510 automatic analyzer, which was used in conjunction with a Davies Model 502 magnetic tape playback system. The complete playback and analysis system is shown in Figure 3.

The Model 502 magnetic tape playback system had been modified to provide playback at either 15 or 30 inches per second. The tape playback contains a servo-control system which permits playback of the tape within very close tolerances of its originally recorded speed. During playback the output from all fourteen tracks is fed simultaneously into the fourteen FM playback discriminators. The output signal from each of the twelve data channels is a 1 to 1 reproduction of the original analog signal.

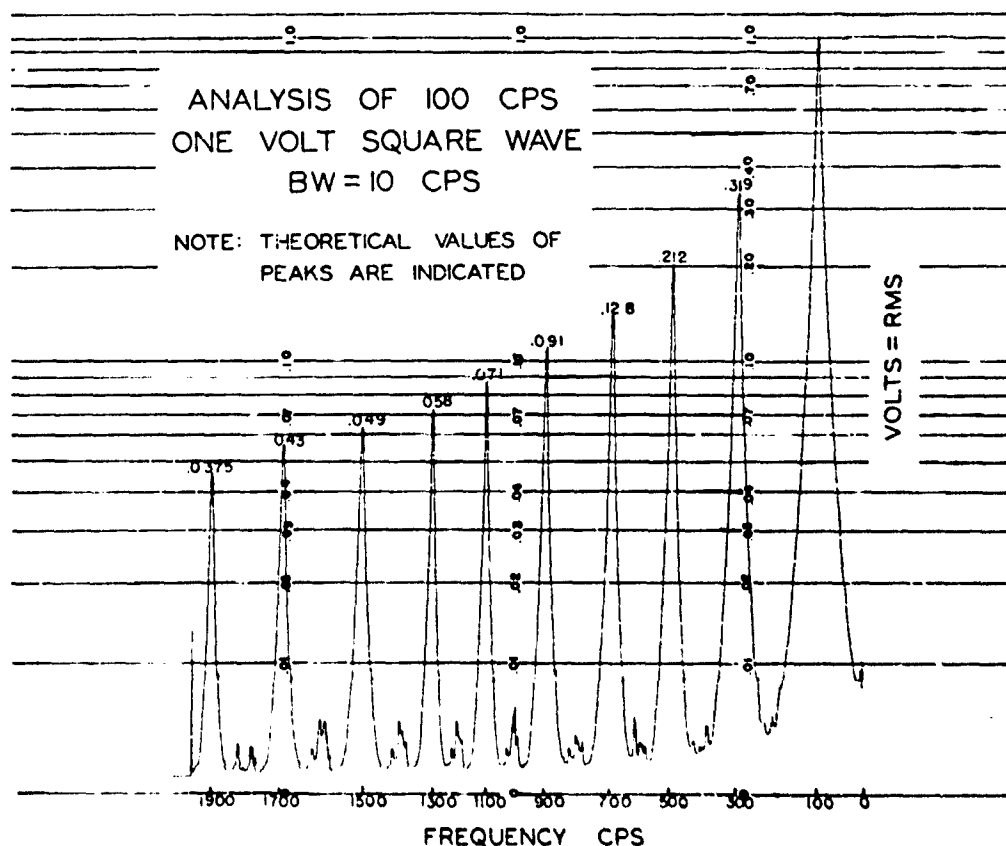
Figure 4. Analysis of 100 cps One Volt Square Wave

The Davies Model 510 automatic analyzer is a constant-bandwidth, heterodyne analyzer complete with motor-driven, variable frequency oscillator. The system has six separate analyzers and can analyze six data channels simultaneously. Both the oscillator scanning rate and analyzer bandwidth are adjustable over the following limits: (1) scan rate 0.3 to 3.0 cps/sec. and (2) bandwidth 1 to 40 cps. The output of the six wave analyzer channels was fed into six modified Brown strip chart recorders. A continuous spectrum plot of frequency (cps) vs voltage (rms) was produced by the strip chart recorders. The chart speed is servo-controlled and can be varied from 0.08 to 13.5 inches per minute. The voltage was plotted on a logarithmic scale and the time required for full-scale deflection, i.e., zero to one volt, was approximately two seconds. A sample analysis of a 100-cps square wave is shown in Figure 4.

In selecting the bandwidth to be used in an analysis of this type, the following must be considered: (1) the frequency resolution desired, (2) the rate of scan, (3) the length of the data sample, (4) the time available for data analysis, (5) the quantity of data to be analyzed, (6) the type of data being analyzed, and (7) the type of presentation of the completed data. Based on a consideration of these variables, a bandwidth of ten cycles per second was selected for these analyses.

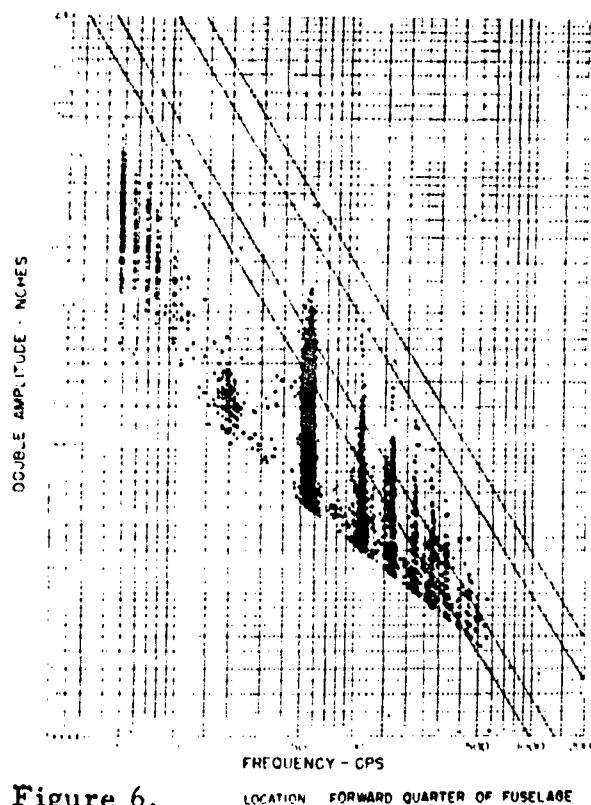
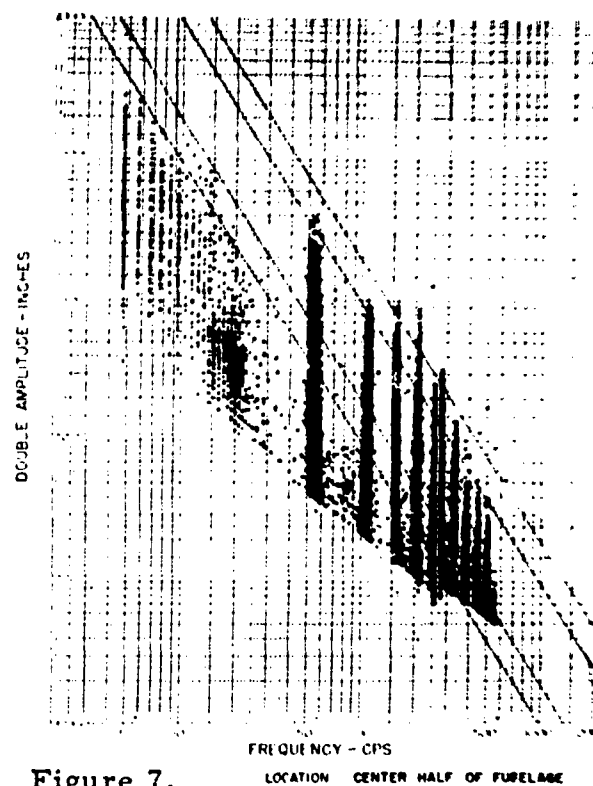
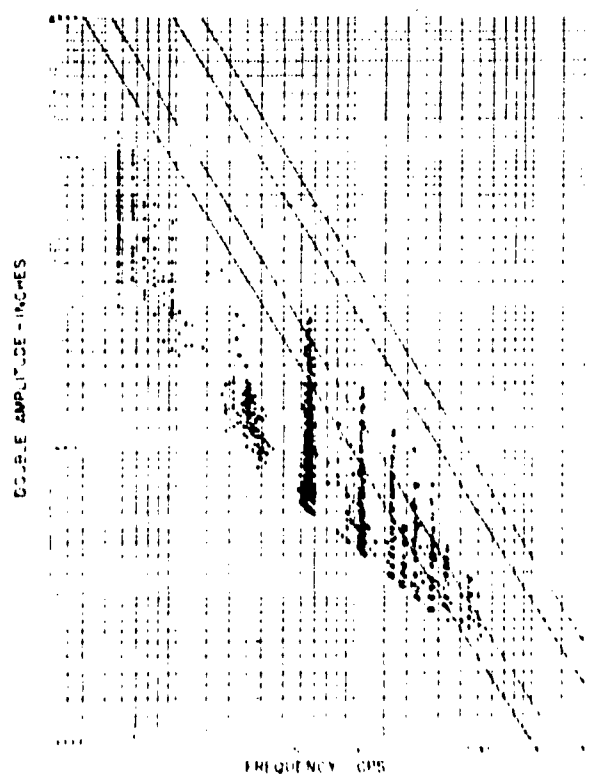
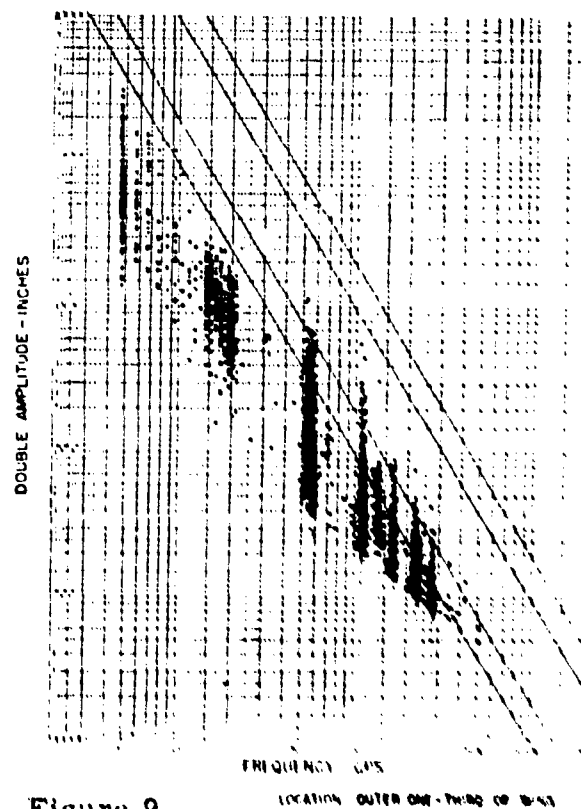
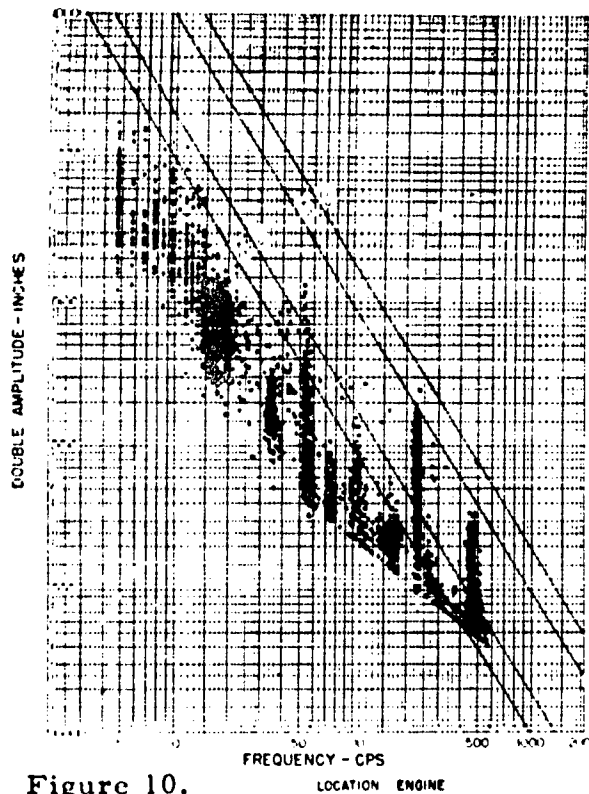
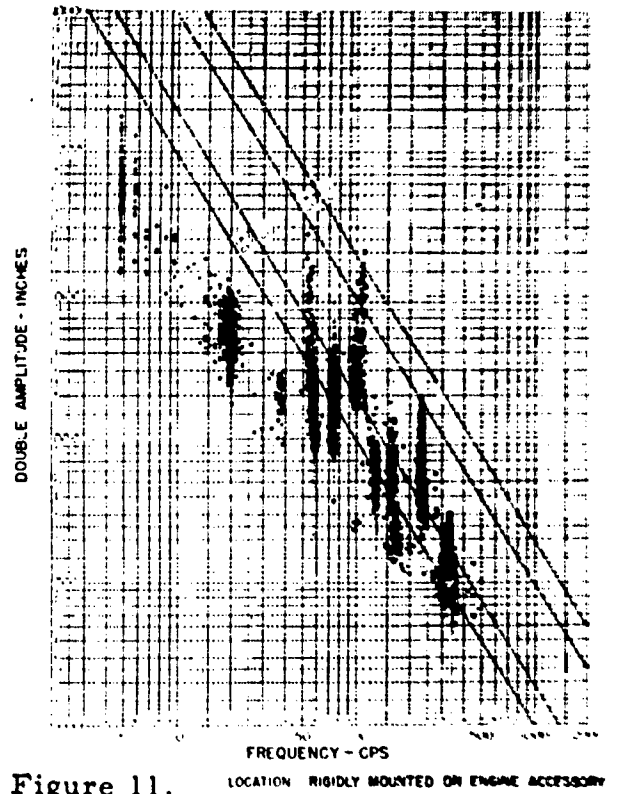
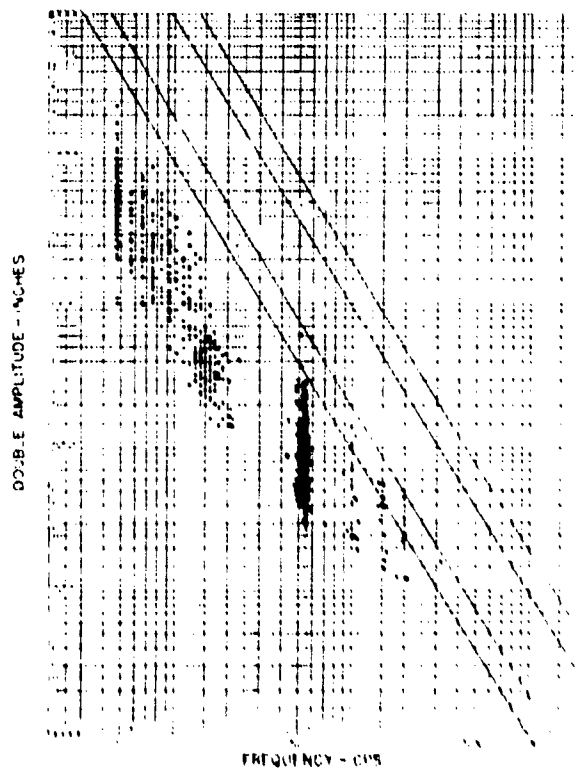
Figures 6 to 9. Summary Plots for Structural Zones

All graphs are log-log (3 x 5 cycle) plots of frequency vs. vibratory double amplitude. As indicated previously, the logs of frequency, double amplitude, and acceleration were determined during the computation phase of data reduction. These

Approximately 50,700 data points were obtained during the five test flights which comprised this survey. As expected and as shown by the graphs presented in Appendix A, the data are of the discrete frequency type. The dominant source of these frequencies is the propeller. However, in the case of the pickups mounted on the engine, vibration frequencies due to engine and accessory unbalance occurred constantly.

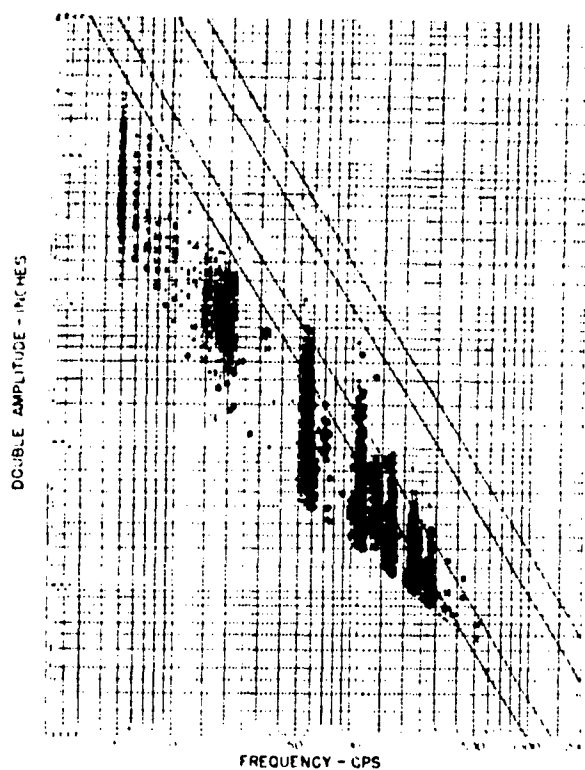
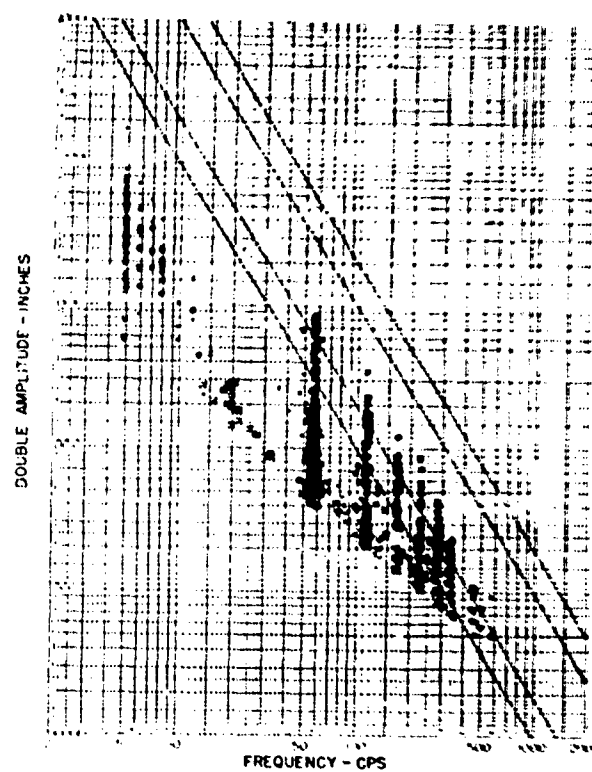
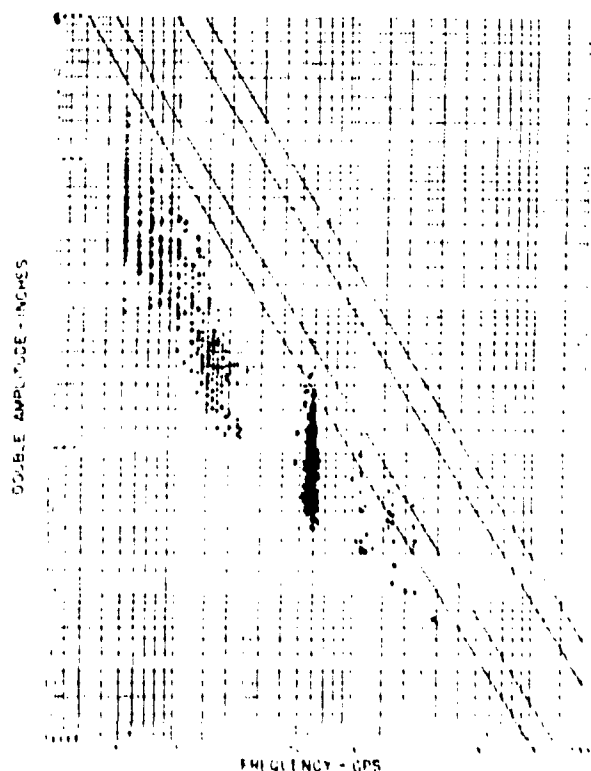
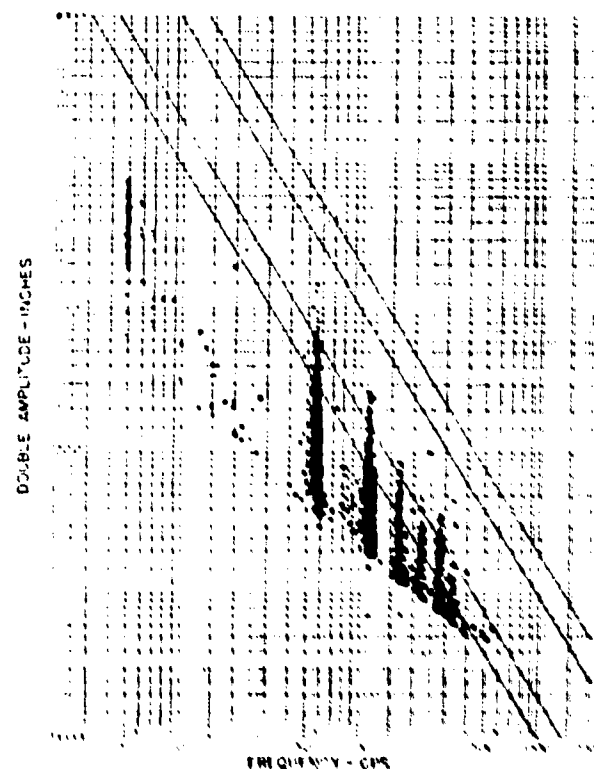
Figures 13 to 16. Summary Plots for Clusters of Two or Three Pickups

The Type 2 graphs present the overall vibration environment, measured under all test conditions, at each of the test points where 2 or 3 pickups were mounted in a cluster.
